USAAVLABS TECHNICAL REPORT 69-92

HOT CORROSION RESISTANCE OF MATERIALS FOR SMALL GAS TURBINE RECUPERATORS

December 1969

**THE GARRETT CORPORATION
AIRESEARCH MANUFACTURING COMPANY
LOS ANGELES, CALIFORNIA**

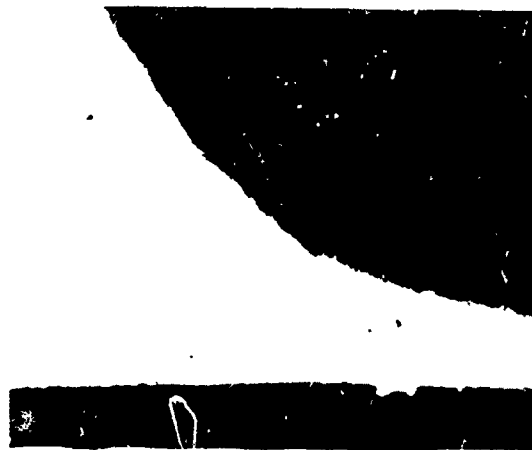
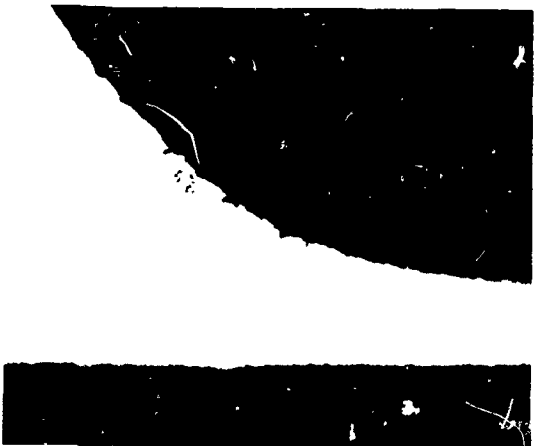
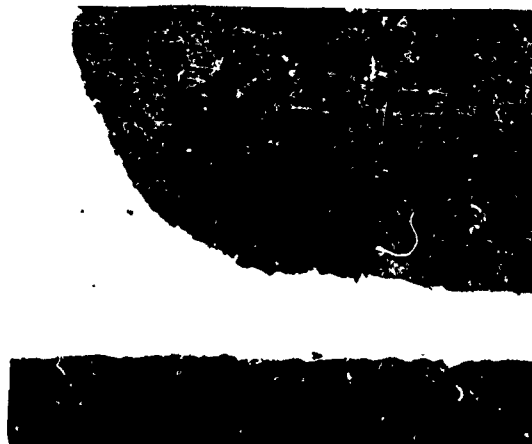
- a. PALNIRO 4 BRAZING ALLOY, VACUUM BRAZED AT 2170°F WITH HOLD TIME OF 10 MIN. NO CORROSION OF PALNIRO 4. UNETCHED

- b. J-8100 BRAZING ALLOY, VACUUM BRAZED AT 2150°F WITH HOLD TIME OF 10 MIN. NO CORROSION OF J-8100. UNETCHED

- c. PALNIRO 1 BRAZING ALLOY, VACUUM BRAZED AT 2070°F WITH HOLD TIME OF 10 MIN. NO CORROSION OF PALNIRO 1. UNETCHED

- d. MICROBRAZ 135 BRAZING ALLOY, VACUUM BRAZED AT 2000°F WITH HOLD TIME OF 10 MIN. SOME CORROSION OF MICROBRAZ 135 NOTED. UNETCHED

Figure 13. Hastelloy X Tube-Header Joints After 100 hr at 1500°F, Static Hot Corrosion Test.

The 1-in.-long tube-header samples were sectioned longitudinally, and their microstructures were examined for the effects of the static hot corrosion test. Photomicrographs of the brazed joints in the unetched condition are shown in Figures 13 through 17. These figures show the resistance of the various tube material/filler metal combinations to the corrosive atmospheres at 1500°F for 100 hr.

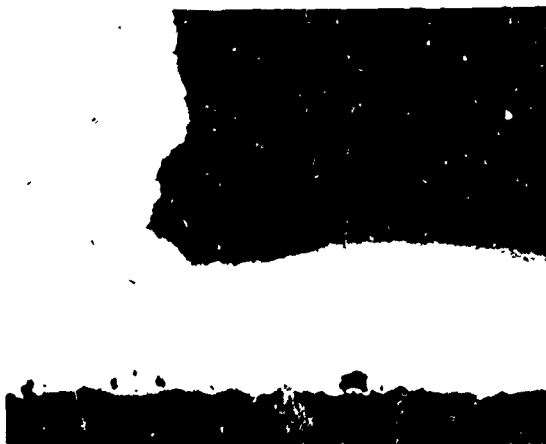
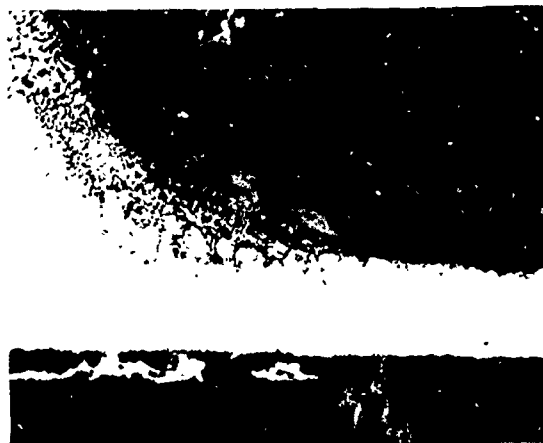
- a. J-8100 BRAZING ALLOY. VACUUM BRAZED AT 2150°F WITH HOLD TIME OF 10 MIN. NO CORROSION OF J-8100 NOTED. UNETCHED

- b. ENGELHARD 135 BRAZING ALLOY. BRAZED AT 2100°F IN HYDROGEN ATMOSPHERE WITH 10 MIN HOLD TIME. EXTENSIVE CORROSION OF ENGELHARD 135 OCCURRED. UNETCHED

- c. MICROBRAZ 135 BRAZING ALLOY. VACUUM BRAZED AT 2000°F WITH HOLD TIME OF 10 MIN. SOME CORROSION OF MICROBRAZ 135 NOTED. UNETCHED

- d. MICROBRAZ 65 BRAZING ALLOY. BRAZED AT 1950°F IN HYDROGEN WITH HOLD TIME OF 10 MIN. HEAVY CORROSION OF MICROBRAZ 65. UNETCHED

Figure 14. Inconel 625 Tube-Header Joints After 100 hr at 1500°F, Static Hot Corrosion Test.

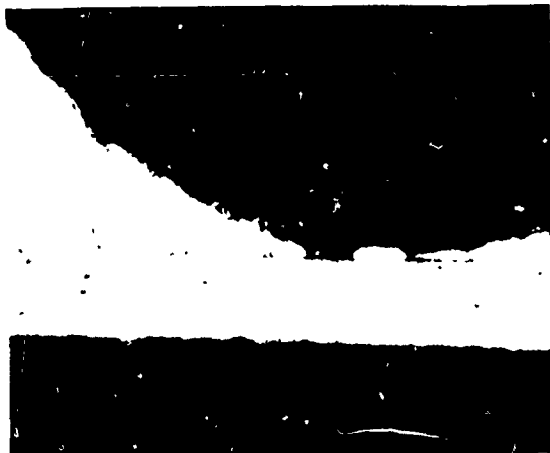
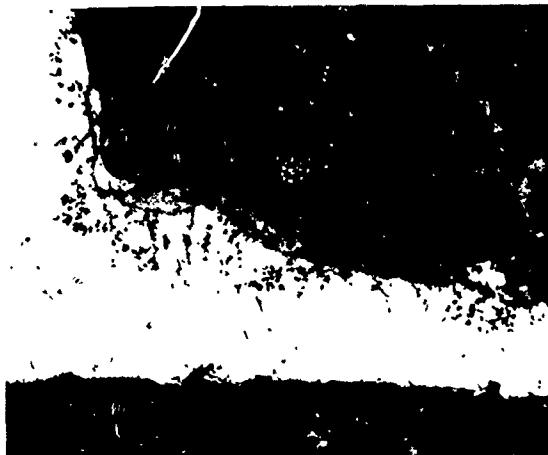
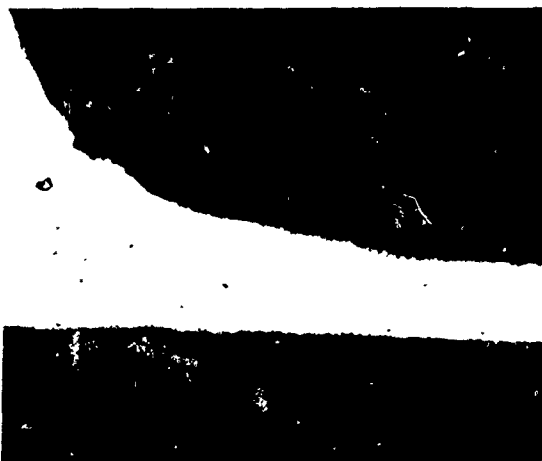
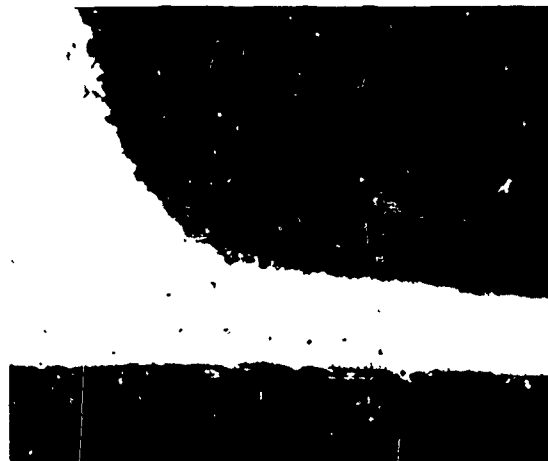
- a. MICROBRAZ 135 BRAZING ALLOY. VACUUM BRAZED AT 2000°F WITH 10 MIN HOLD TIME. SOME CORROSION OF MICROBRAZ 135 NOTED. UNETCHED

- b. MICROBRAZ 65 BRAZING ALLOY. BRAZED AT 1950°F IN HYDROGEN WITH 10 MIN HOLD TIME. EXTENSIVE CORROSION OF MICROBRAZ 65. UNETCHED

- c. PALNIRO 7 BRAZING ALLOY. VACUUM BRAZED AT 1950°F WITH 10 MIN HOLD TIME. NO CORROSION OF PALNIRO 7 NOTED. UNETCHED

- d. COAST METALS 50B BRAZING ALLOY. VACUUM BRAZED AT 2050°F WITH 10 MIN HOLD TIME. SOME CORROSION OF 50B NOTED. UNETCHED

Figure 15. Incoloy 800 Tube-Header Joints After 100 hr at 1500°F, Static Hot Corrosion Test.

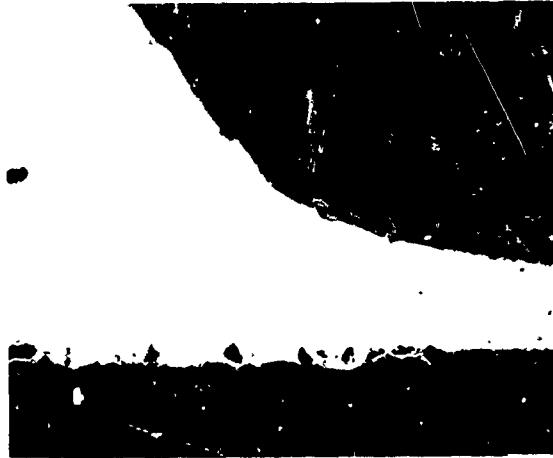
- a. PALNIRO 4 BRAZING ALLOY. VACUUM BRAZED AT 2175°F WITH 10 MIN HOLD TIME. NEGLIGIBLE CORROSION OF PALNIRO 4 NOTED. UNETCHED

- b. J-8100 BRAZING ALLOY. VACUUM BRAZED AT 2150°F WITH 10 MIN HOLD TIME. NO CORROSION OF J-8100 NOTED. UNETCHED

- c. PALNIRO 1 BRAZING ALLOY. VACUUM BRAZED AT 2075°F WITH 10 MIN HOLD TIME. NO CORROSION OF PALNIRO 1 NOTED. UNETCHED

- d. MICROBRAZ 200 BRAZING ALLOY. VACUUM BRAZED AT 1950°F WITH 10 MIN HOLD TIME. SLIGHT CORROSION OF MICROBRAZ 200 NOTED. UNETCHED

Figure 16. N-155 Tube-Header Joints After 100 hr at 1500°F, Static Hot Corrosion Test.

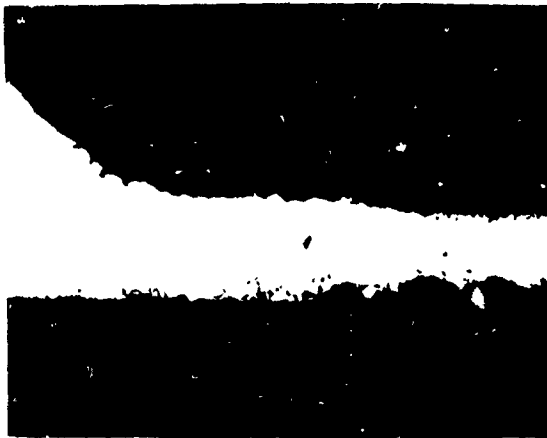
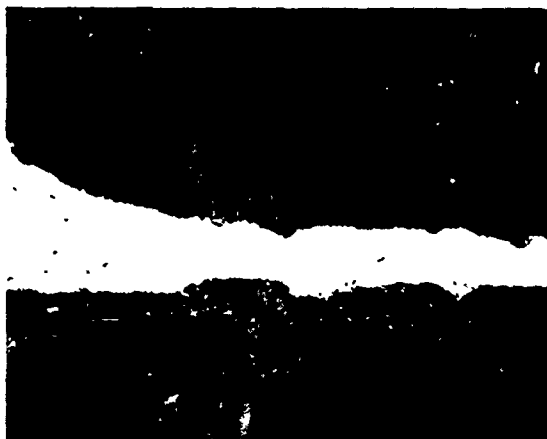
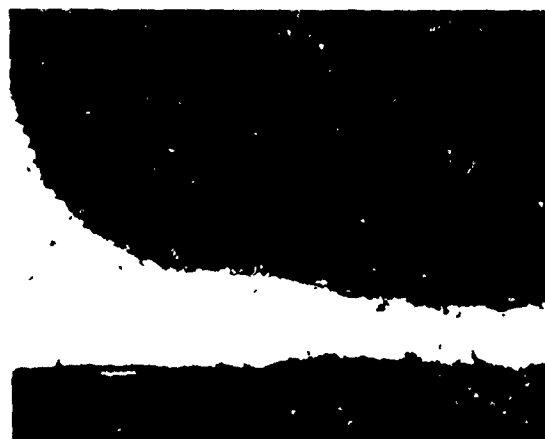
- a. MICROBRAZ 135 BRAZING ALLOY, VACUUM BRAZED AT 2000°F WITH 10 MIN HOLD TIME. SOME CORROSION OF MICROBRAZ 135 NOTED. UNETCHED

- b. MICROBRAZ 65 BRAZING ALLOY, BRAZED AT 1950°F IN HYDROGEN WITH 10 MIN HOLD TIME. CORROSION OF MICROBRAZ 65 NOTED. UNETCHED

- c. PALNIRO 7 BRAZING ALLOY, VACUUM BRAZED AT 1950°F WITH 10 MIN HOLD TIME. NO CORROSION OF PALNIRO 7 NOTED. UNETCHED

- d. COAST METALS 508 BRAZING ALLOY, VACUUM BRAZED AT 2050°F WITH 10 MIN HOLD TIME. SOME CORROSION OF 508 NOTED. UNETCHED

Figure 17. Type 347 Stainless Steel Tube-Header Joints at 1500°F, Static Hot Corrosion Test.

With the exception of type 347 stainless steel, none of the tube-header joints showed more than superficial corrosion. The stainless steel, however, was more heavily oxidized, as can be seen in Figure 17. Palniro 4, J-8100, Palniro 1, Palniro 7, and Nicrobraz 200 filler metals were not attacked by the sulfurous atmosphere. Nicrobraz 135 and Coast Metals 50B suffered moderate attack, and Nicrobraz 65 and Englehard 135 were both severely corroded.

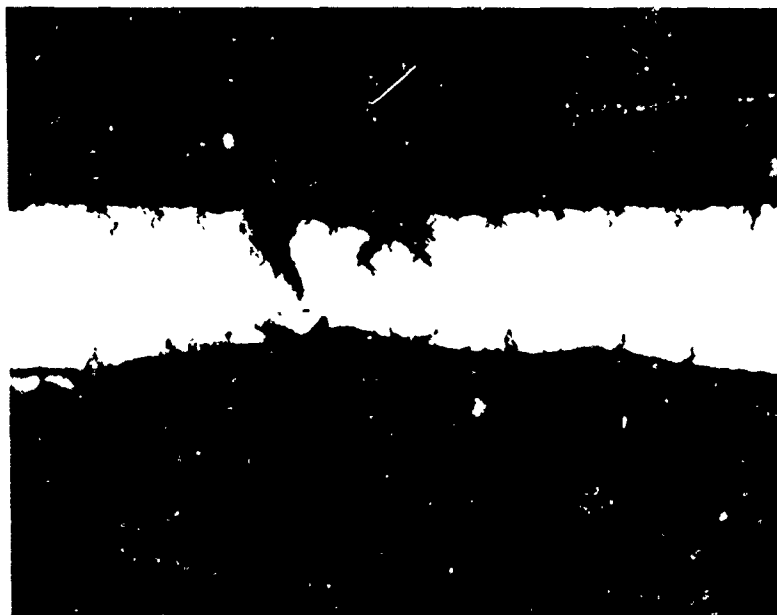
MAG = X230

Figure 23. Hastelloy X After a 204-hr Exposure at 1300°F and 20.8 ksi.

Grain boundary attack was clearly evident after Hastelloy X was submitted to high stress levels for both the 1500° and 1300°F conditions. No appreciable oxide layer was detected on any sample examined, but in some cases the grain boundaries were so severely attacked that the tube wall was almost penetrated. This type of corrosion is illustrated in Figure 23, which shows Hastelloy X after 204 hr at 1300°F and 0.8 ksi. Concentration of the attack in the grain boundaries is not surprising with such high stresses involved. Loss of cohesive strength at the grain boundaries is the normal mode of stress-rupture failure; consequently, the effects of hot corrosion may have been slight. Microprobe analysis identified the corrosion product as a chromium oxide phase, free of nickel or iron oxides, which adhered to a metal layer depleted in chromium content. No sulfides were associated with the oxide.

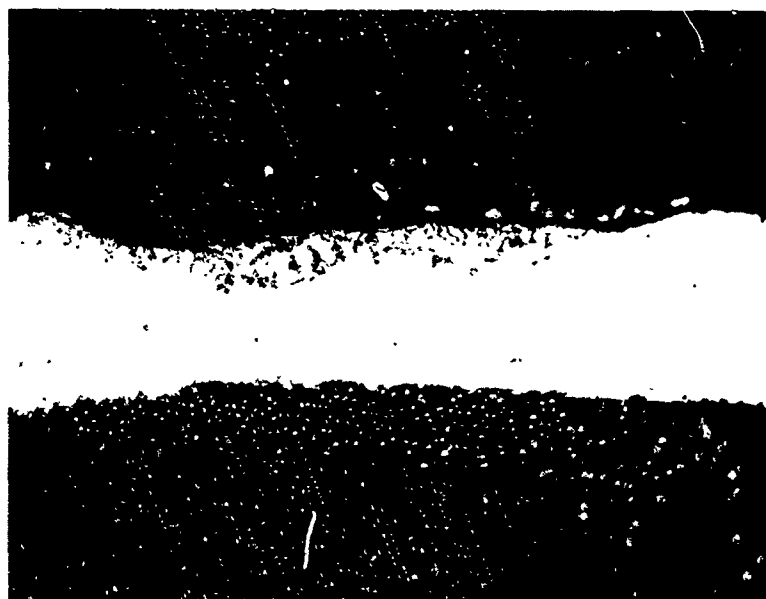
MAG = X250

Figure 24. N-155 After a 87.9-hr Exposure at 1300°F and 26.7 ksi.

At 1500°F and high stresses, N-155 oxidation occurred along the grain boundaries and resulted in the ultimate stress-rupture failure of the tube. The material also appeared to be subject to "wart" attack. On isolated tubes, severe corrosion occurred over a limited tube surface area, which resulted in a relatively massive oxide spot that in some cases almost penetrated the tube wall thickness. With the exception of these "warts," oxidation was, in general, slight at low stresses or low temperatures. Electron microprobe analysis identified the oxide as a mixture of iron, chromium, cobalt, and possible manganese oxides. No sulfides were detected. Figure 24 depicts the type of oxide layer found on N-155 tubing material.

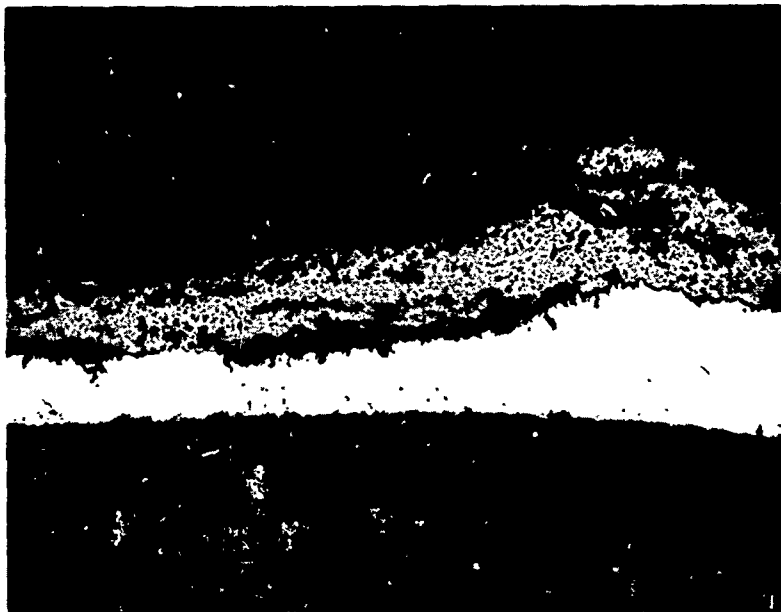
Figure 26. Type 347 Stainless Steel After 77.4 hr at 1500°F and 3.0 ksi.

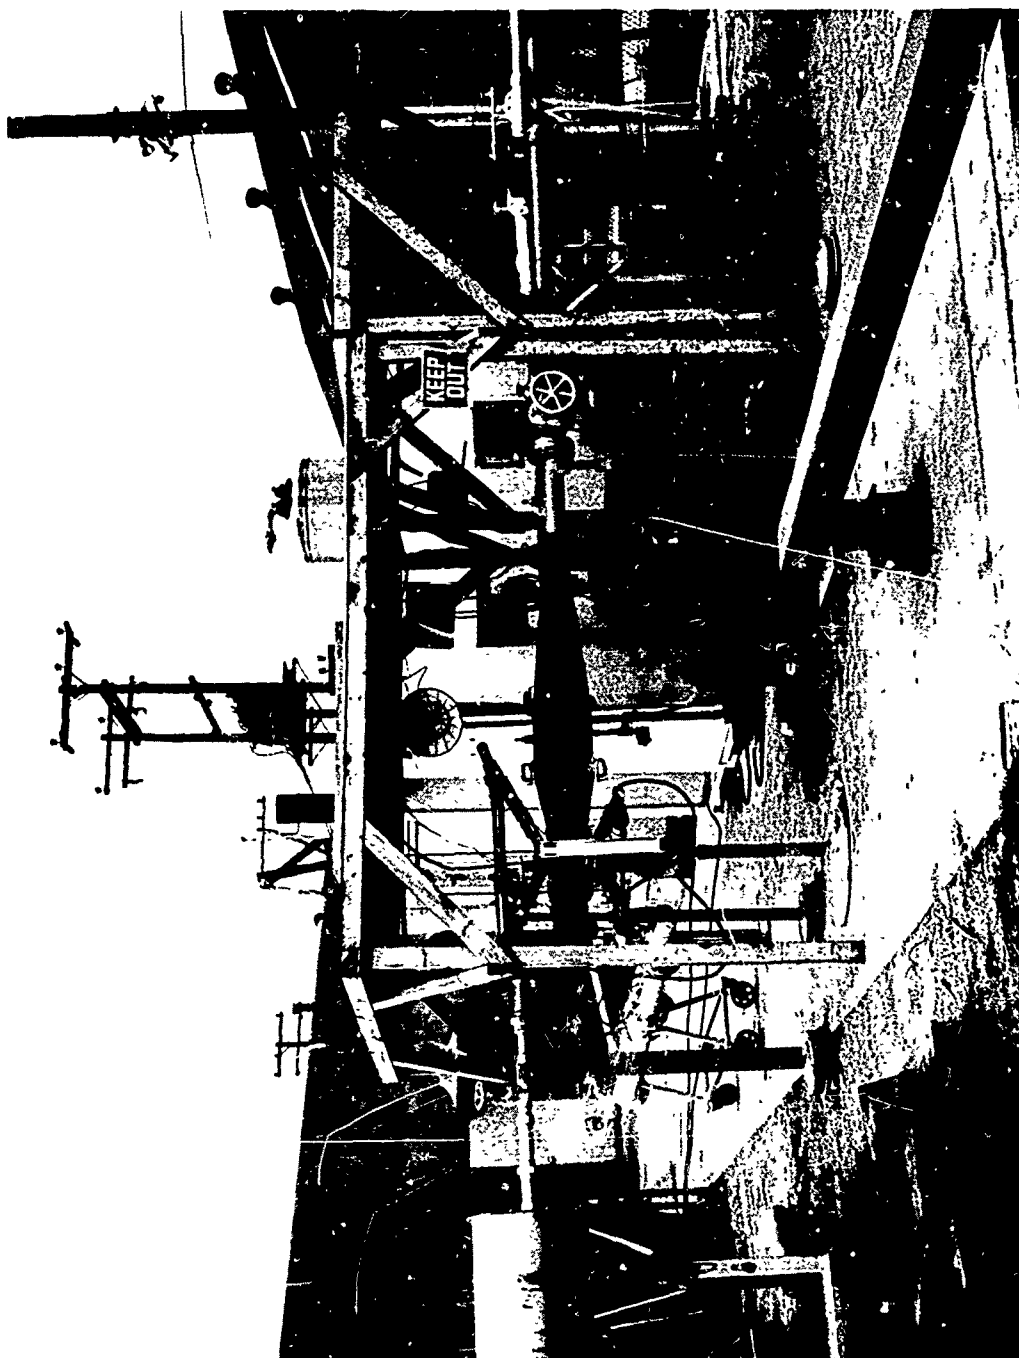
Figure 41. General View of Recuperator Hot Corrosion Test Setup.

All test instrumentation used in the test program was certified to comply with the accuracies and calibration procedures of MIL-C-45662A, with traceability to the National Bureau of Standards. Photographs of the combustor test rig are shown in Figures 40 and 41.

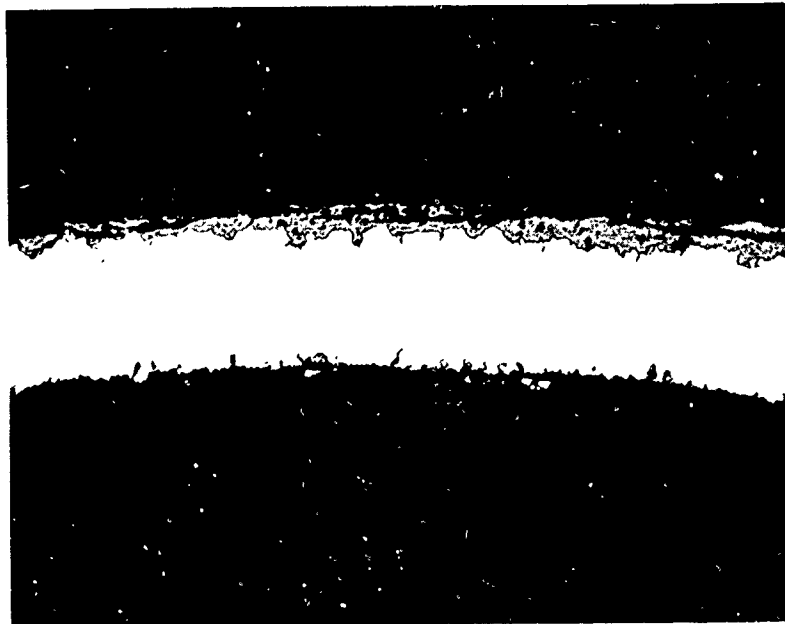
Figure 51. Incoloy 800 Exposed for 464 hr at 1500°F to 0.1-ppm Maximum Sea Salts in Recuperator Test Rig (Module 6-2).

An oxide layer approximately 0.6 mil thick was observed on the portion of the tube heated to 1500°F, and some intergranular penetration had occurred on the outside, and to a lesser extent on the inside, tube surfaces (see Figure 51). Microprobe analysis confirmed the oxide thickness.

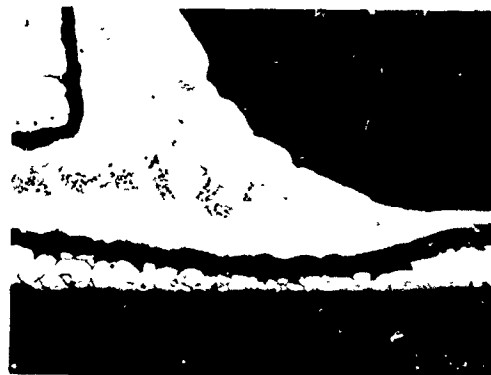
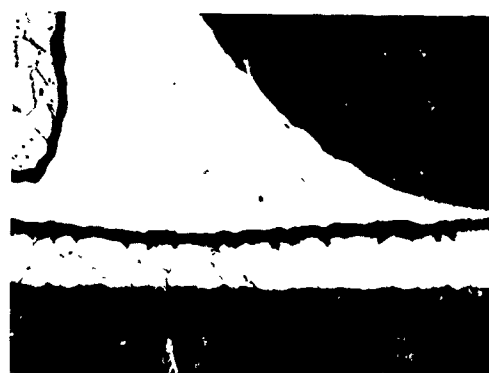
a. 2200°F BRAZING TEMPERATURE.

b. 2200°F BRAZING TEMPERATURE.

c. 2175°F BRAZING TEMPERATURE.

d. 2175°F BRAZING TEMPERATURE.

e. 2150°F BRAZING TEMPERATURE.

f. 2150°F BRAZING TEMPERATURE.

Figure 57. Photomicrographs of Hastelloy X Tube-Header Joints Brazed With Palniro 4 Brazing Alloy, in Vacuum, With a 10-Min Hold Time at Temperature. Etched With Kalling's Reagent.

Tube-header joints were brazed with each of the five selected materials and the four selected braze alloys. After brazing, the 1-in.-long samples were sectioned longitudinally and prepared for metallographical evaluation. The results of this examination are presented in the main body of the report. Figures 57 through 76, presented in this appendix, illustrate the microstructures of the various tube material brazing alloy combinations after brazing at the three predetermined brazing temperatures for 10 min each.

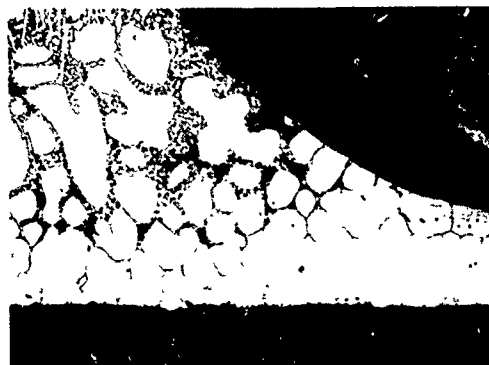
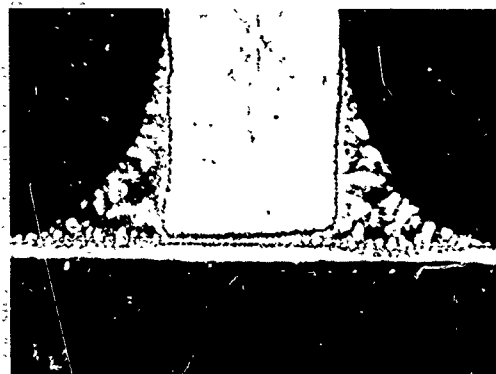
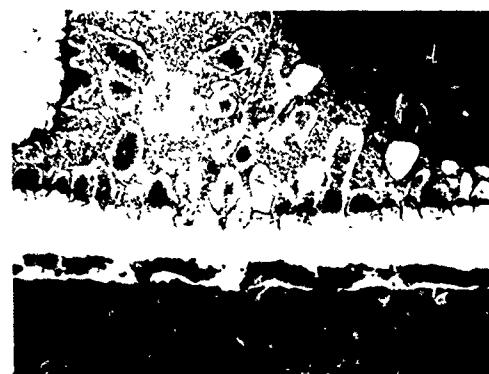
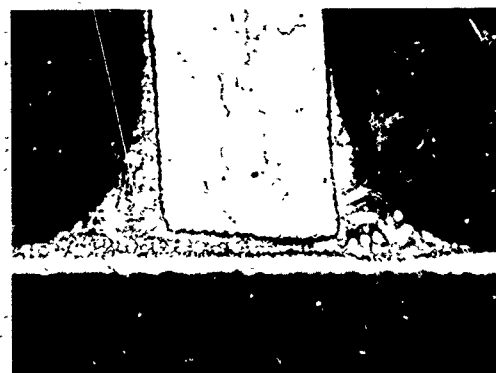
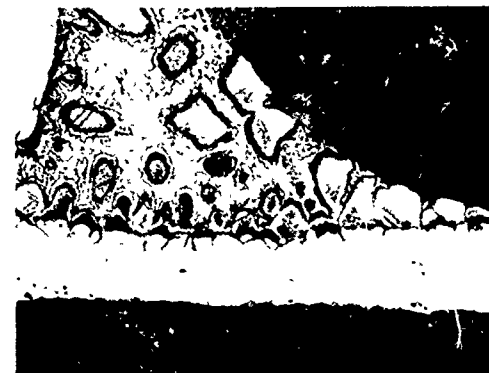
a. 2175°F BRAZING TEMPERATURE.

b. 2175°F BRAZING TEMPERATURE.

c. 2150°F BRAZING TEMPERATURE.

d. 2150°F BRAZING TEMPERATURE.

e. 2125°F BRAZING TEMPERATURE.

f. 2125°F BRAZING TEMPERATURE.

Figure 58. Photomicrographs of Hastelloy X Tube-Header Joints Brazed With J-8100 Brazing Alloy, in Vacuum, With a 10-Min Hold Time at Temperature. Etched With Kalling's Reagent.

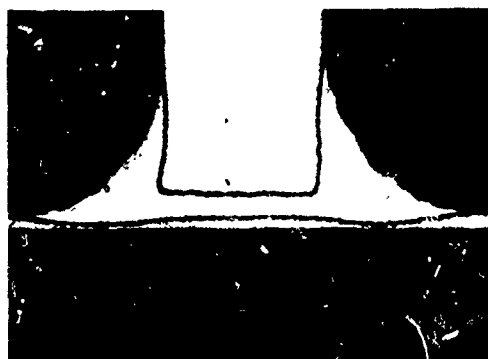
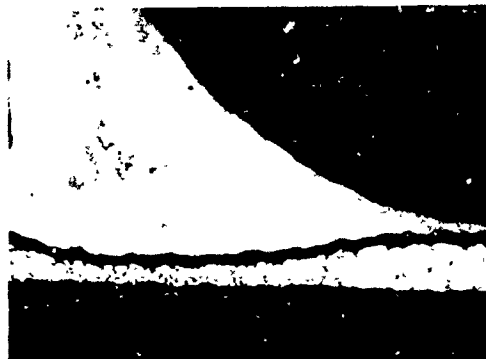
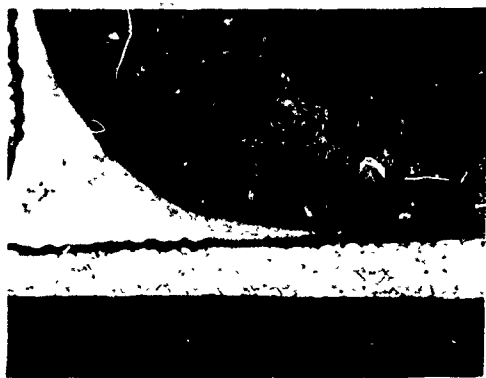
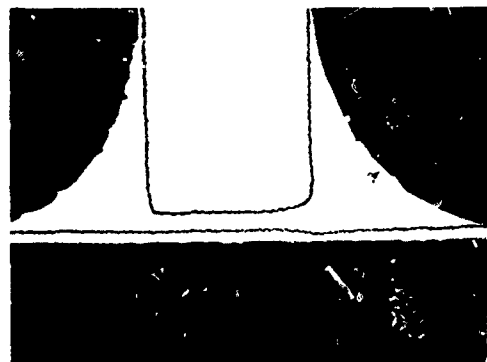
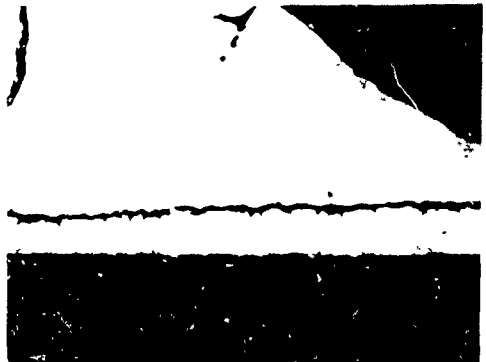
a. 2100°F BRAZING TEMPERATURE.

b. 2100°F BRAZING TEMPERATURE.

c. 2075°F BRAZING TEMPERATURE.

d. 2075°F BRAZING TEMPERATURE.

e. 2050°F BRAZING TEMPERATURE.

f. 2050°F BRAZING TEMPERATURE.

Figure 59. Photomicrographs of Hastelloy X Tube-Header Joints Brazed With Palniro I Brazing Alloy, in Vacuum, With a 10-Min Hold Time at Temperature. Etched With Kalling's Reagent.

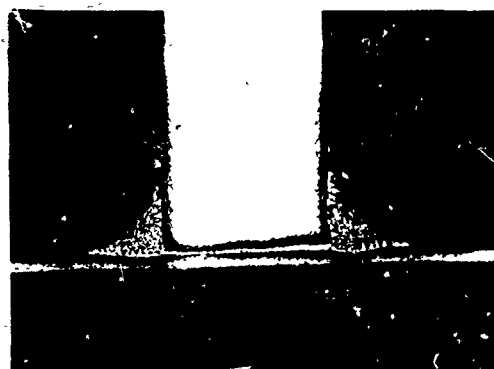
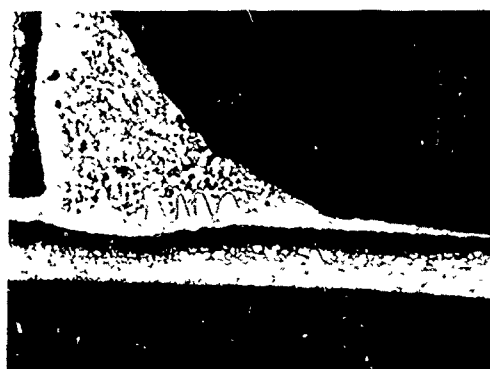
a. 2025°F BRAZING TEMPERATURE.

b. 2025°F BRAZING TEMPERATURE.

c. 2000°F BRAZING TEMPERATURE.

d. 2000°F BRAZING TEMPERATURE.

e. 1975°F BRAZING TEMPERATURE.

f. 1975°F BRAZING TEMPERATURE.

Figure 60. Photomicrographs of Hastelloy X Tube-Header Joints Brazed With Microbraz 135 Brazing Alloy, in Vacuum, With a 10-min Hold Time at Temperature. Etched With Kalling's Reagent.

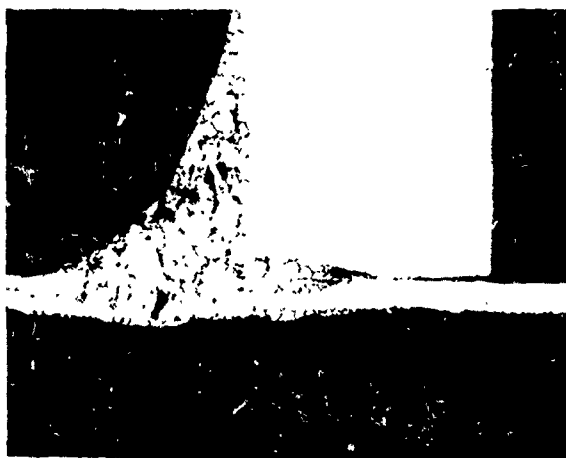
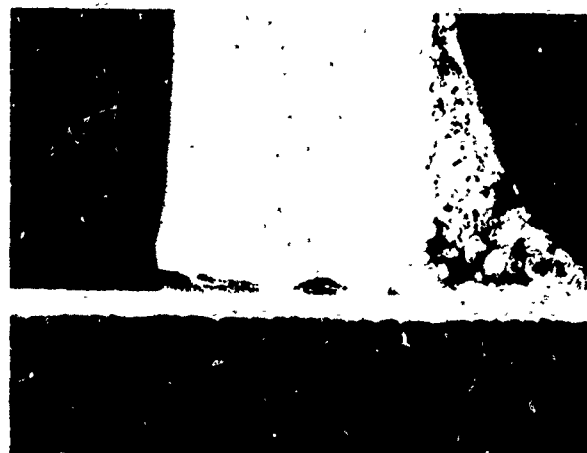
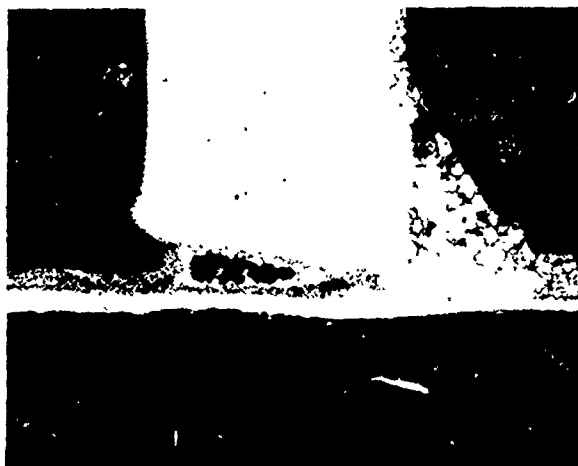
a. 2175°F BRAZING TEMPERATURE.

b. 2150°F BRAZING TEMPERATURE.

c. 2125°F BRAZING TEMPERATURE.

Figure 61. Photomicrographs of Inconel 625 Tube-Header Joints Brazed With J-8100 Brazing Alloy, in Vacuum, With a 10-Min Hold Time at Temperature. Etched With Kalling's Reagent.

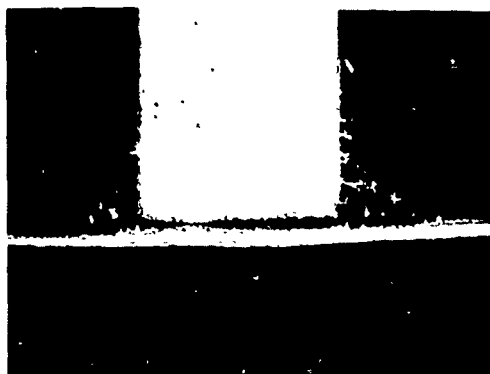
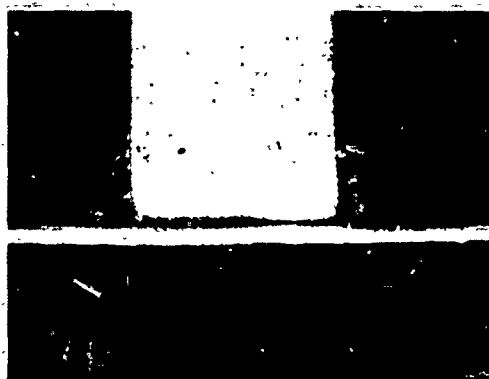
a. 2125°F BRAZING TEMPERATURE.

b. 2125°F BRAZING TEMPERATURE.

c. 2100°F BRAZING TEMPERATURE.

d. 2100°F BRAZING TEMPERATURE.

e. 2075°F BRAZING TEMPERATURE.

f. 2075°F BRAZING TEMPERATURE.

Figure 62. Photomicrographs of Inconel 625 Tube-Header Joints Brazed With Engelhard 135 Brazing Alloy, in Hydrogen, With a 10-Min Hold Time at Temperature. Etched With Kalling's Reagent.

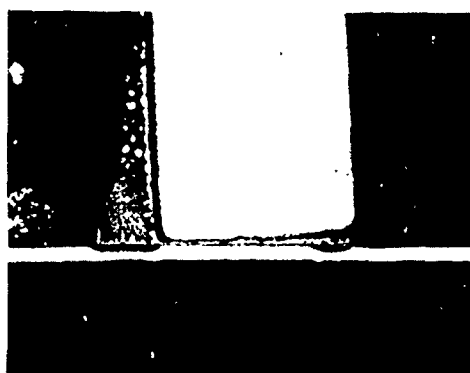
a. 2025°F BRAZING TEMPERATURE.

b. 2025°F BRAZING TEMPERATURE.

c. 2000°F BRAZING TEMPERATURE.

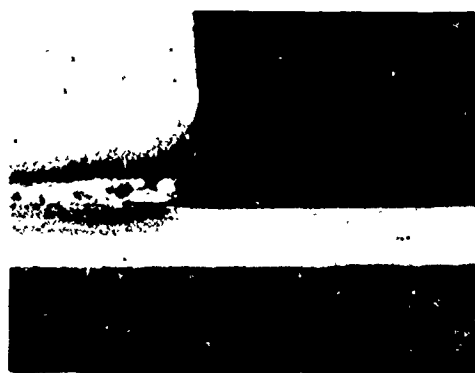
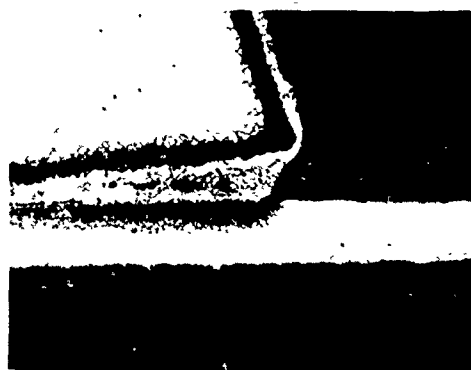
d. 2000°F BRAZING TEMPERATURE.

e. 1975°F BRAZING TEMPERATURE.

f. 1975°F BRAZING TEMPERATURE.

Figure 63. Photomicrographs of Inconel 625 Tube-Header Joints Brazed With Microbraz 135 Brazing Alloy, in Vacuum, With a 10-Min Hold Time at Temperature. Etched With Kalling's Reagent.

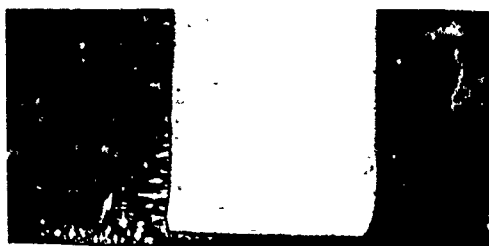
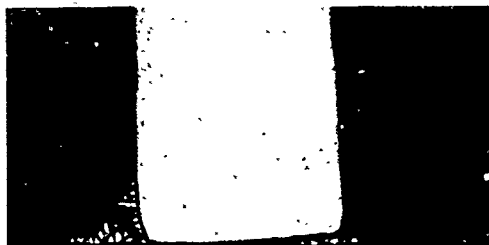
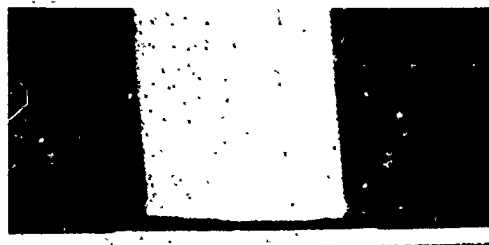
a. 1975°F BRAZING TEMPERATURE.

b. 1975°F BRAZING TEMPERATURE.

c. 1950°F BRAZING TEMPERATURE.

d. 1950°F BRAZING TEMPERATURE.

e. 1925°F BRAZING TEMPERATURE.

f. 1925°F BRAZING TEMPERATURE.

Figure 64. Photomicrographs of Inconel 625 Tube-Header Joints Brazed With Microbraz 65 Brazing Alloy, in Hydrogen, With a 10-Min Hold Time at Temperature. Etched With Kalling's Reagent.

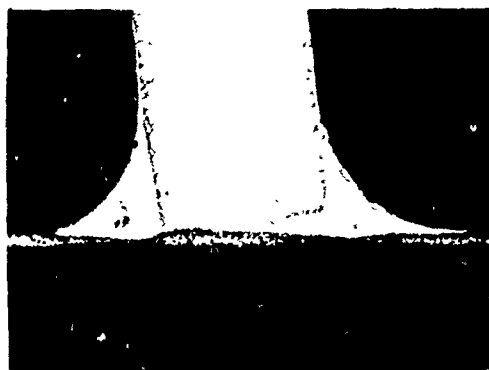
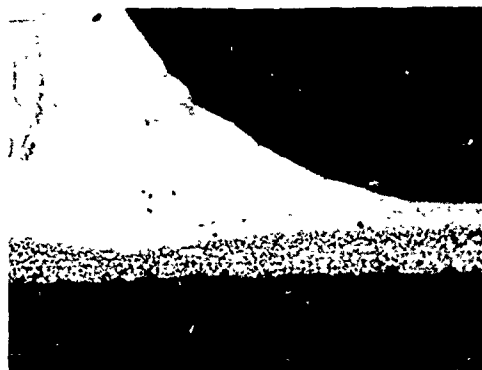
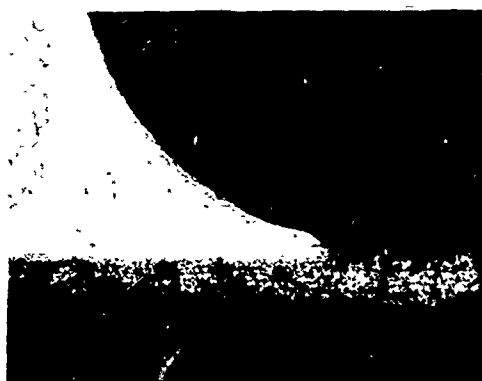
a. 2025°F BRAZING TEMPERATURE.

b. 2025°F BRAZING TEMPERATURE.

c. 2000°F BRAZING TEMPERATURE.

d. 2000°F BRAZING TEMPERATURE.

e. 1975°F BRAZING TEMPERATURE.

f. 1975°F BRAZING TEMPERATURE.

Figure 65. Photomicrographs of Incoloy 800 Tube-Header Joints Brazed With Microbraz 135 Brazing Alloy, in Vacuum, With a 10-Min Hold Time at Temperature. Etched With Kalling's Reagent.

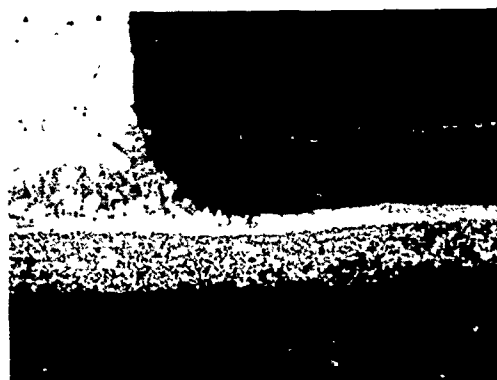
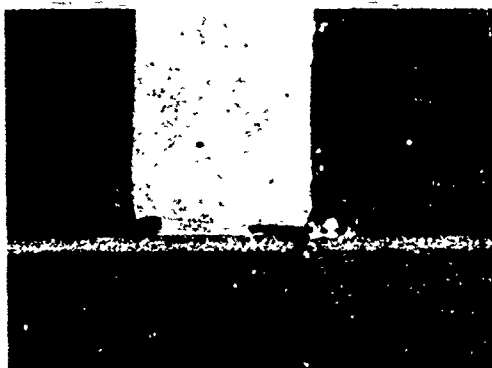
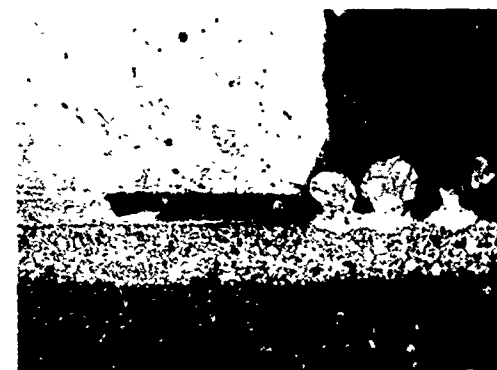
a. 1975°F BRAZING TEMPERATURE

b. 1975°F BRAZING TEMPERATURE

c. 1950°F BRAZING TEMPERATURE

d. 1950°F BRAZING TEMPERATURE

e. 1925°F BRAZING TEMPERATURE

f. 1925°F BRAZING TEMPERATURE

Figure 66. Photomicrographs of Incoloy 800 Tube-Header Joints Brazed With Microbraz 65 Brazing Alloy, in Hydrogen, With a 10-Min Hold Time at Temperature. Etched With Kalling's Reagent.

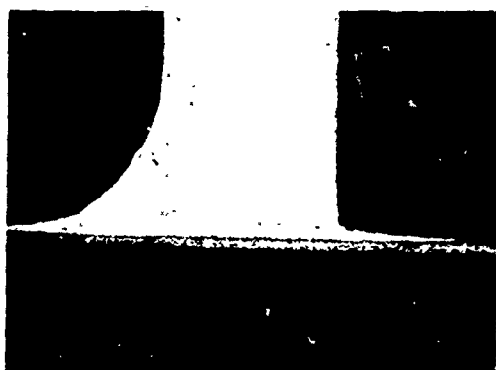
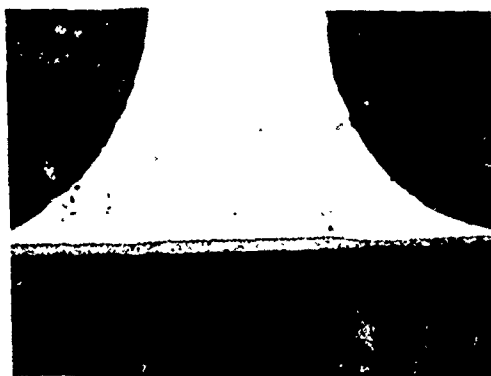
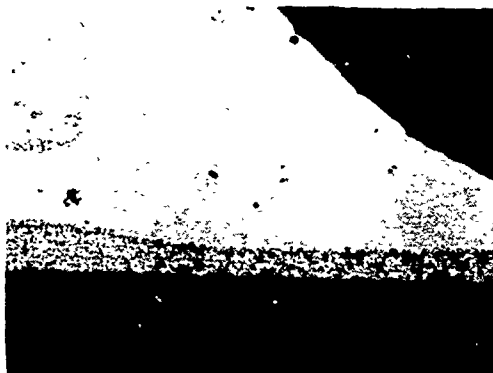
a. 1975°F BRAZING TEMPERATURE

b. 1975°F BRAZING TEMPERATURE

c. 1950°F BRAZING TEMPERATURE

d. 1950°F BRAZING TEMPERATURE

e. 1925°F BRAZING TEMPERATURE

f. 1925°F BRAZING TEMPERATURE

Figure 67. Photomicrographs of Incoloy 800 Tube-Header Joints Brazed With Palniro 7 Brazing Alloy, in Vacuum, With a 10-Min Hold Time at Temperature. Etched With Kalling's Reagent.

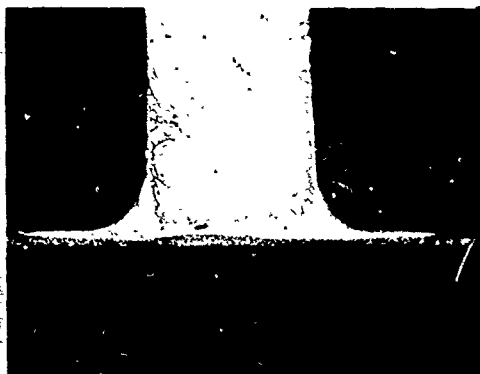
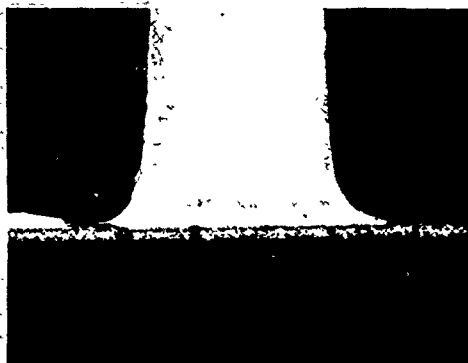
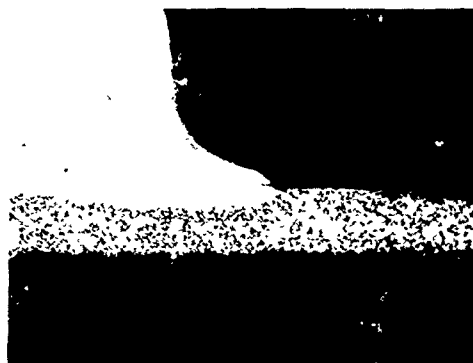
a. 2075°F BRAZING TEMPERATURE.

b. 2075°F BRAZING TEMPERATURE.

c. 2050°F BRAZING TEMPERATURE.

d. 2050°F BRAZING TEMPERATURE.

e. 2025°F BRAZING TEMPERATURE.

f. 2025°F BRAZING TEMPERATURE.

Figure 68. Photomicrographs of Incoloy 800 Tube-Header Joints Brazed With Coast Metals 50B Brazing Alloy, in Vacuum, With a 10-Min Hold Time at Temperature. Etched With Kalling's Reagent.

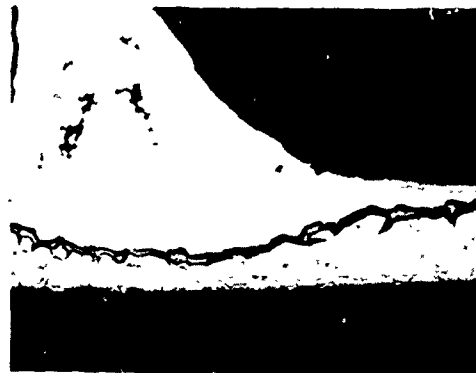
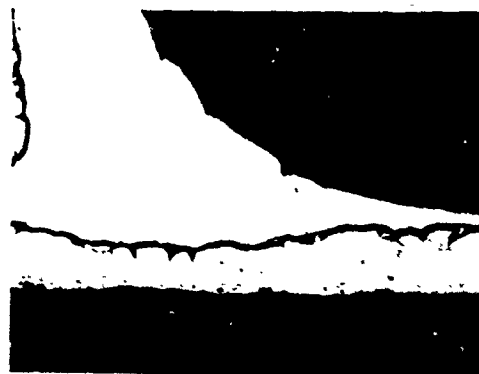
a. 2200°F BRAZING TEMPERATURE.

b. 2200°F BRAZING TEMPERATURE.

c. 2175°F BRAZING TEMPERATURE.

d. 2175°F BRAZING TEMPERATURE.

e. 2150°F BRAZING TEMPERATURE.

f. 2150°F BRAZING TEMPERATURE.

Figure 69. Photomicrographs of Multimet N-155 Tube-Header Joints Brazed With Palniro 4 Brazing Alloy, in Vacuum, With a 10-Min Hold Time at Temperature. Etched With Kalling's Reagent.

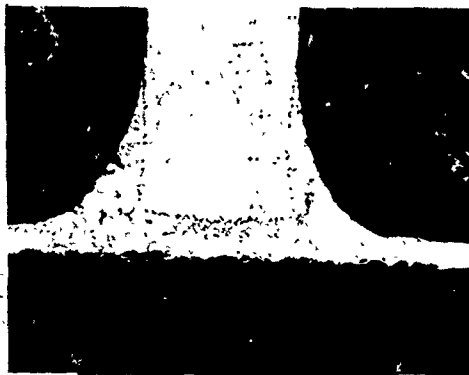
a. 2175°F BRAZING TEMPERATURE.

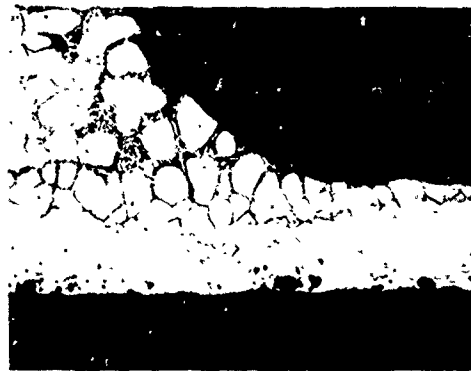
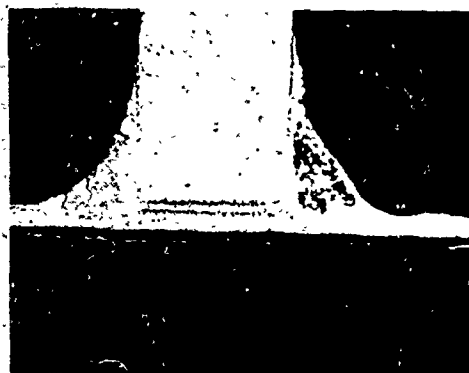
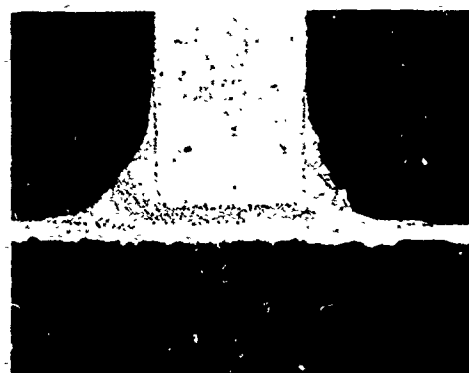
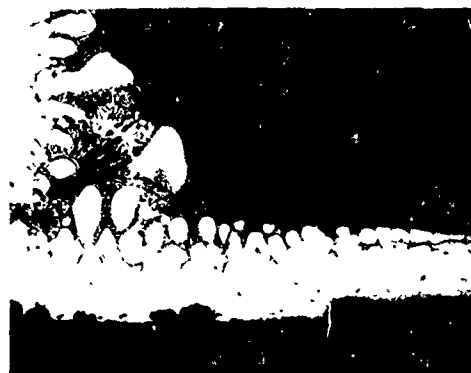
Figure 70. Photomicrographs of Multimet N-155 Tube-Header Joints Brazed With J-8100 Brazing Alloy, in Vacuum, With a 10-Min Hold Time at Temperature. Etched With Kalling's Reagent.

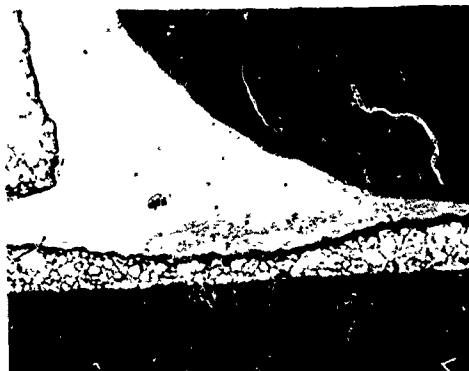
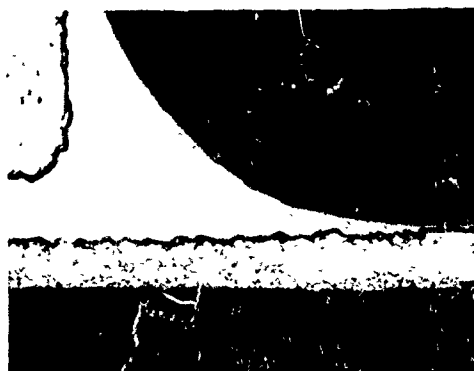
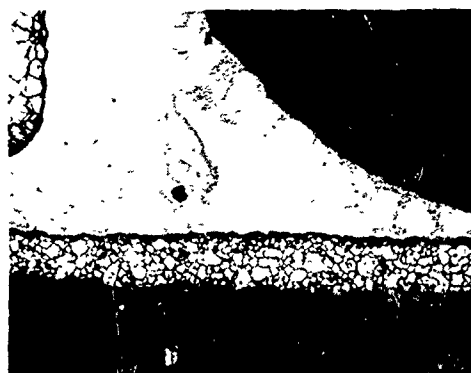
Figure 71. Photomicrographs of Multimet N-155 Tube-Header Joints Brazed With Palniro I Brazing Alloy, in Vacuum, With a 10-Min Hold Time at Temperature. Etched With Kalling's Reagent.

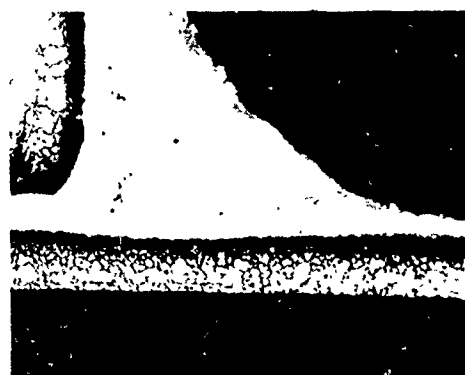
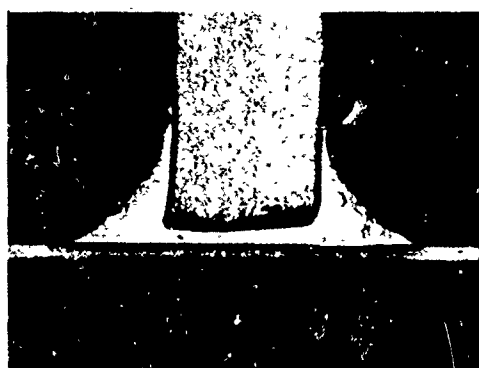
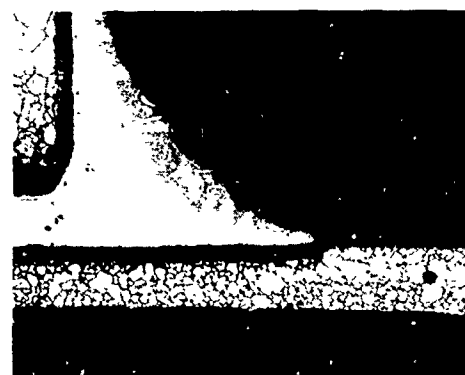
Figure 72. Photomicrographs of Multimet N-155 Tube-Header Joints Brazed With Microbraz 200 Brazing Alloy, in Vacuum, With a 10-Min Hold Time at Temperature. Etched With Kalling's Reagent.

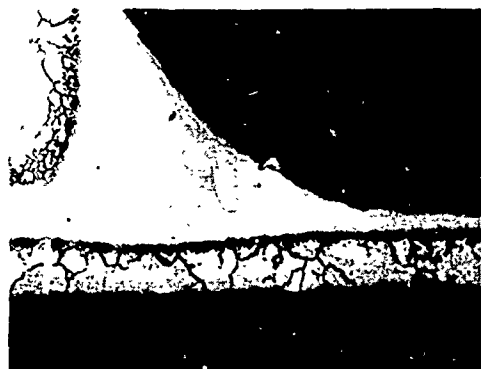
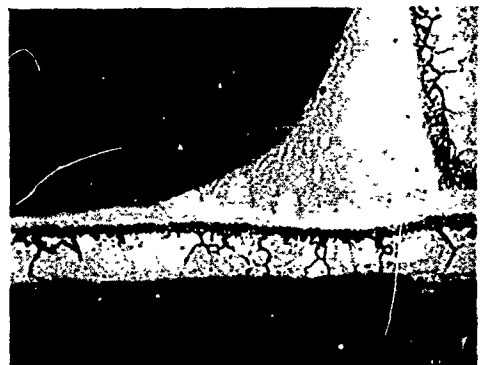
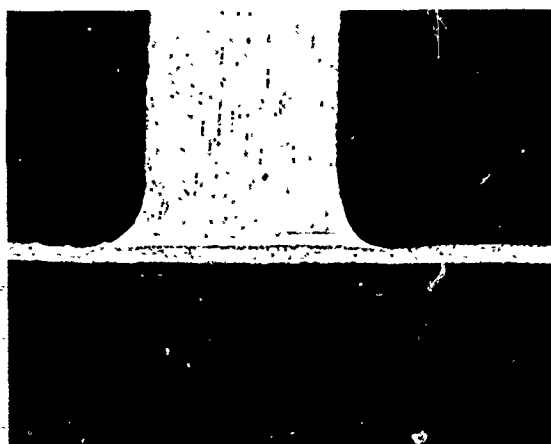
Figure 73. Photomicrographs of Type 347 Stainless Steel Tube-Header Joints Brazed With Microbraz 135 Brazing Alloy, in Vacuum, With a 10-Min Hold Time at Temperature. Etched With Kalling's Reagent.

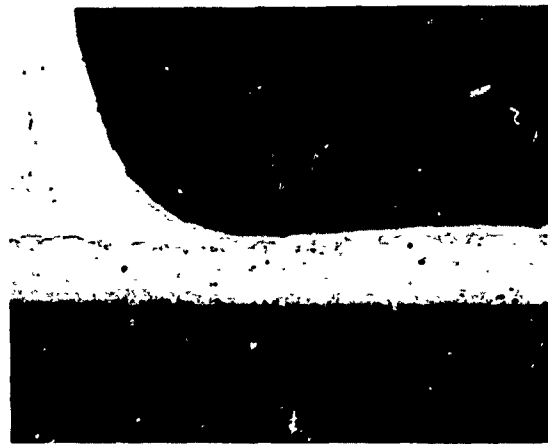
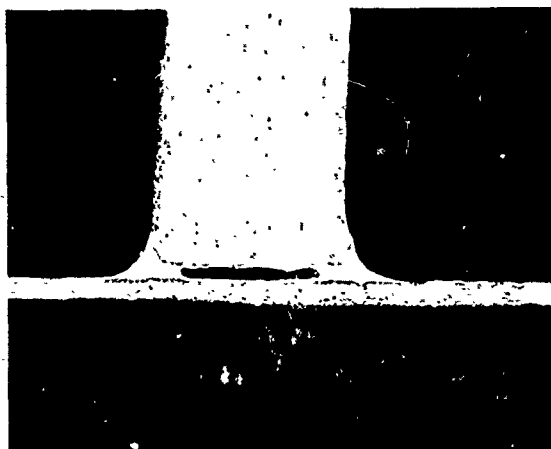
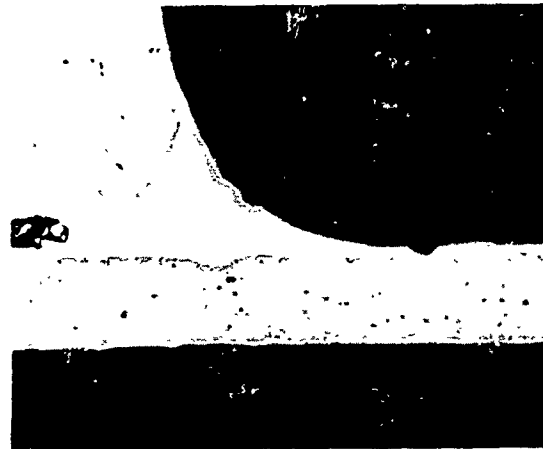
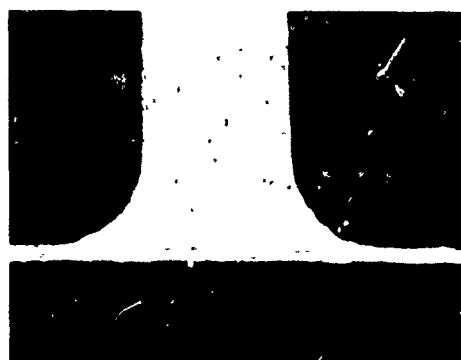
Figure 74. Photomicrographs of Type 347 Stainless Steel Tube-Header Joints Brazed With Microbraz 65 Brazing Alloy, in Hydrogen, With a 10-Min Hold Time at Temperature. Etched With Kalling's Reagent.

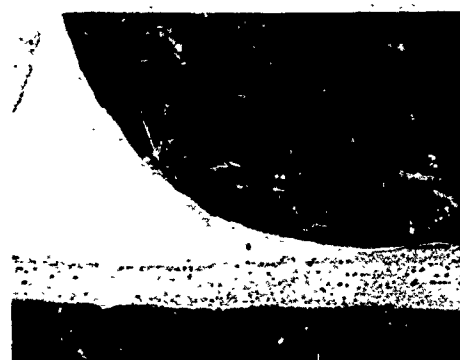
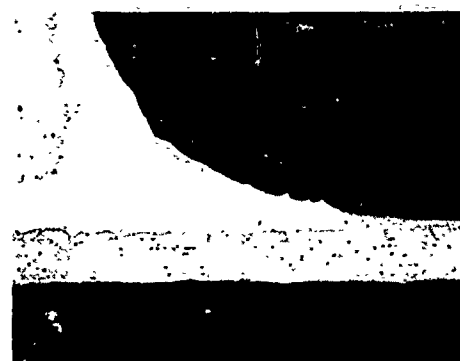
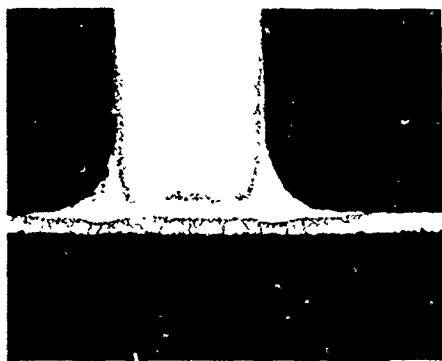
Figure 75. Photomicrographs of Type 347 Stainless Steel Tube-Header Joints Brazed With Palniro 7 Brazing Alloy, in Vacuum, With a 10-Min Hold Time at Temperature. Etched With Kalling's Reagent.

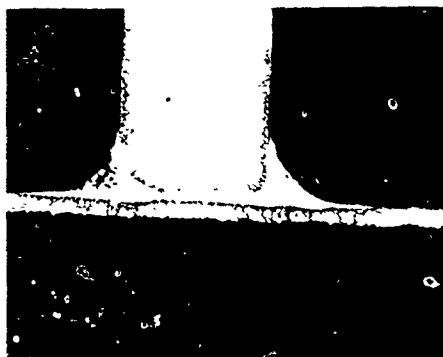
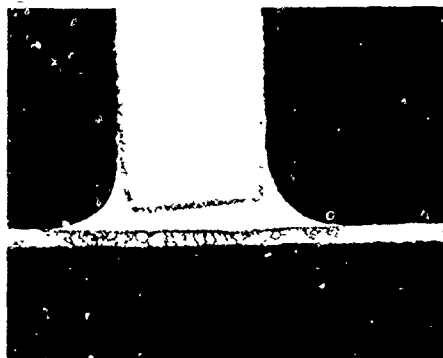
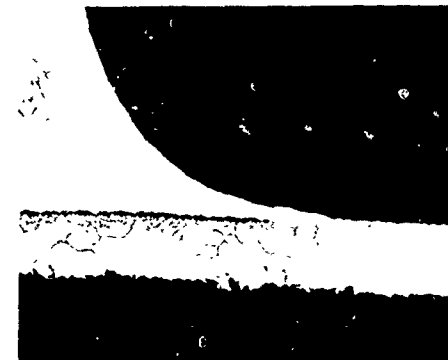
Figure 76. Photomicrographs of Type 347 Stainless Steel Tube-Header Joints Brazed With Coast Metals 50B Brazing Alloy, in Vacuum, With a 10-Min Hold Time at Temperature. Etched With Kalling's Reagent.
